PHASE I ENVIRONMENTAL SITE ASSESSMENT

Quarry Creek Property
Carlsbad, California

May 25, 2012

C Young Associates
1042 Skylark Drive
La Jolla, CA 92037

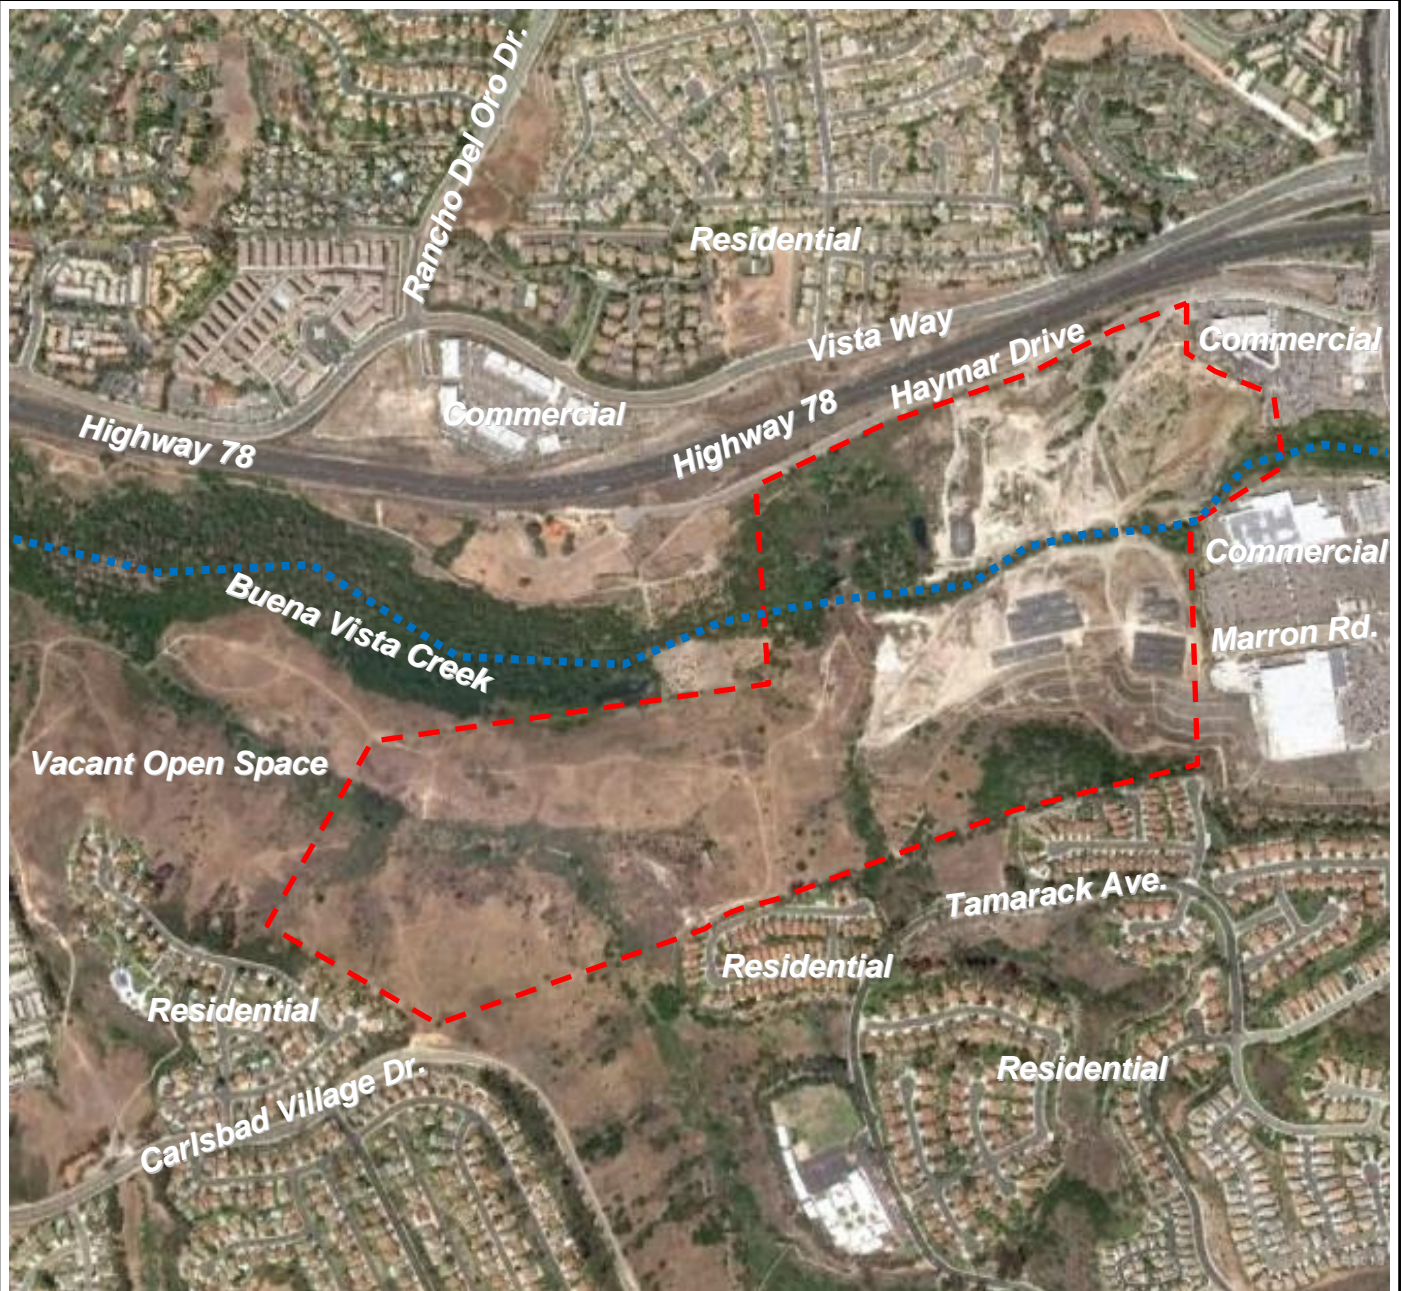
13.2 Site Plan

Approximate Site Boundary

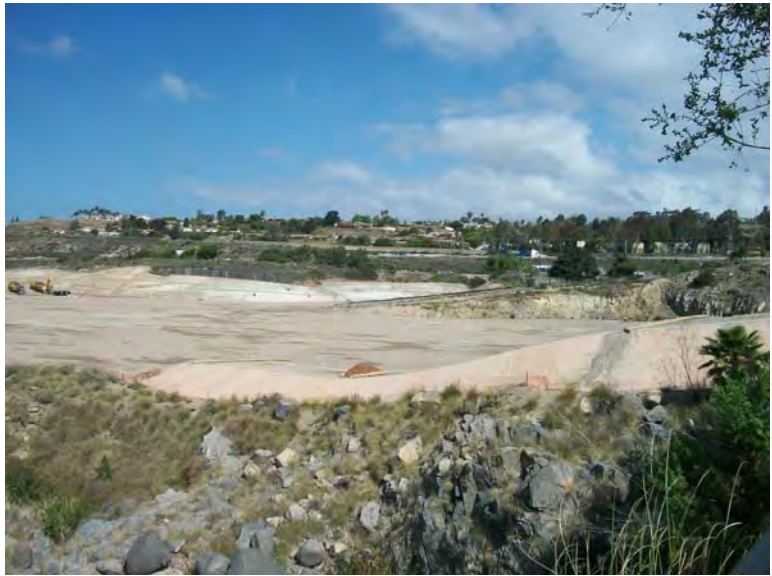
PHOTO 1.

View of the northeastern side of the Site from the eastern Site boundary looking to the northwest.

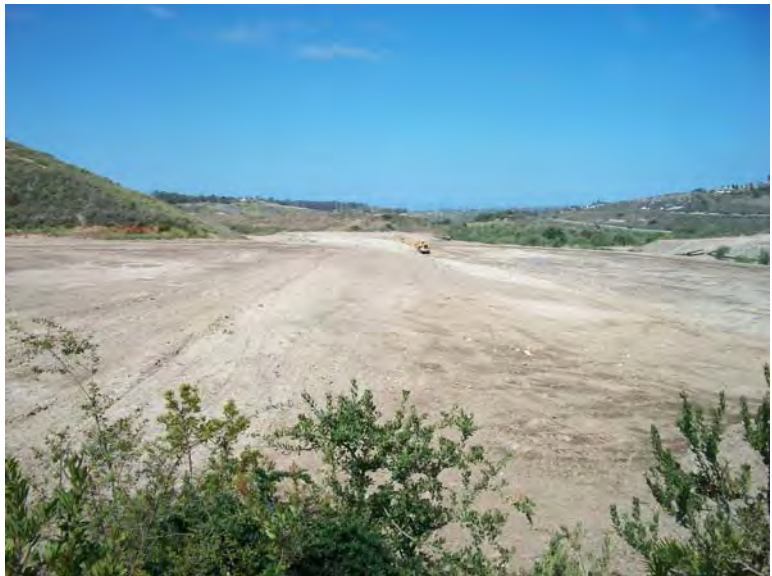
PHOTO 2.

View from the southeastern side of the Site from the eastern Site boundary looking to the west.

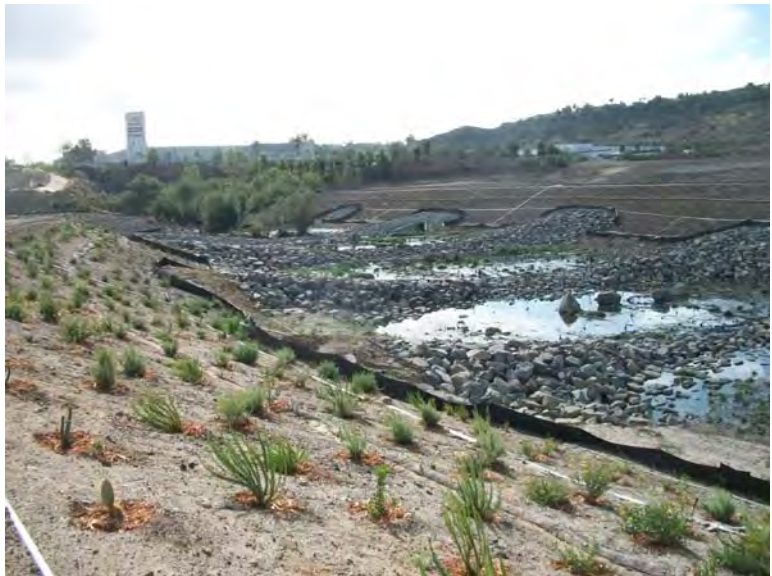
PHOTO 5.

View of Buena Vista Creek located in the central portion of the Site looking to the southeast.

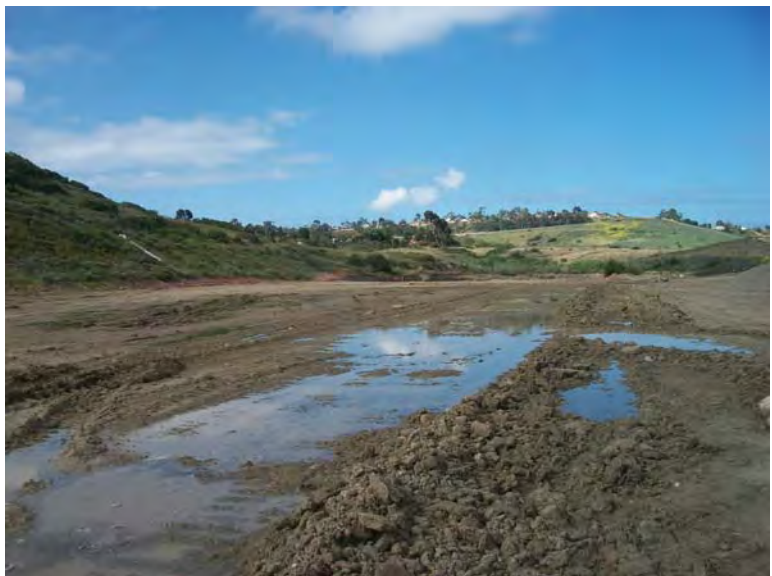
PHOTO 6.

View of the southeastern portion of the Site looking to the southwest.

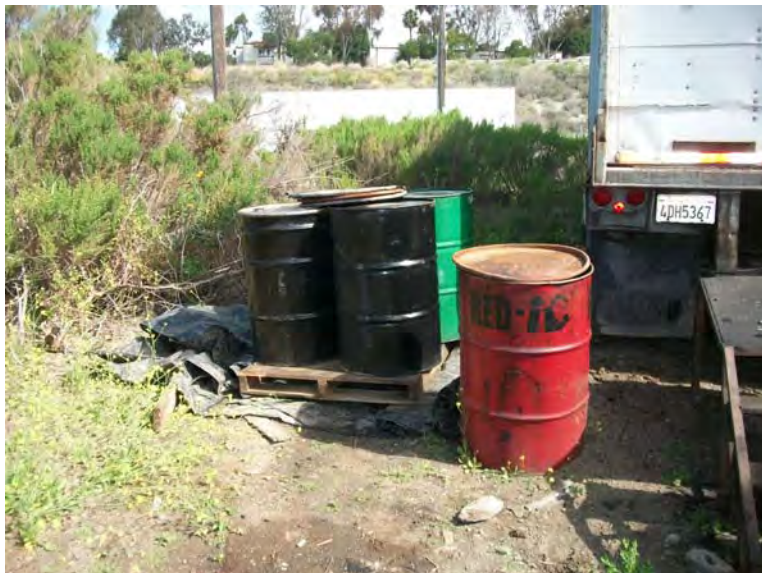
PHOTO 10.

- During the Site reconnaissance, CYA observed five 55-gallon drums of grease and waste oil produced at the Site. They are stored on a pallet with visqueen sheeting beneath in a fenced compound area of the Site in its northeastern area where current tools and equipment are stored. No evidence of releases or staining in the vicinity of the drums was observed. In addition, nine empty 55-gallon drums are stored in this area and will reportedly be used as need to dispose of any hazardous materials/substances. Thus, the presence of the five 55-gallons drums containing stored grease and waste oil prior to offsite disposal and the presence of 9 empty 55-gallon drums is not considered to be an environmental concern to the Site.

View of the waste oil and grease stored in five 55-gallon drums located in the northeastern portion of the Site looking to the north.

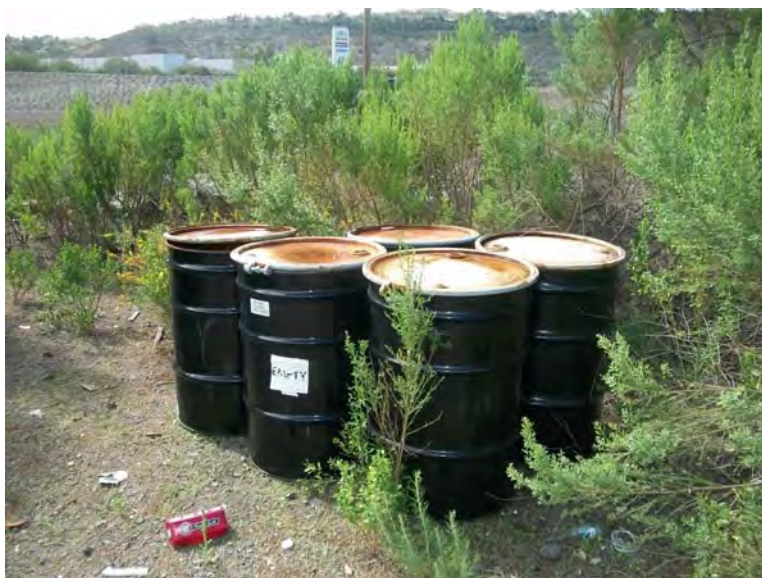
PHOTO 11.

View of five of the nine empty 55-gallon drums observed in the northeastern portion of the Site looking to the southeast.

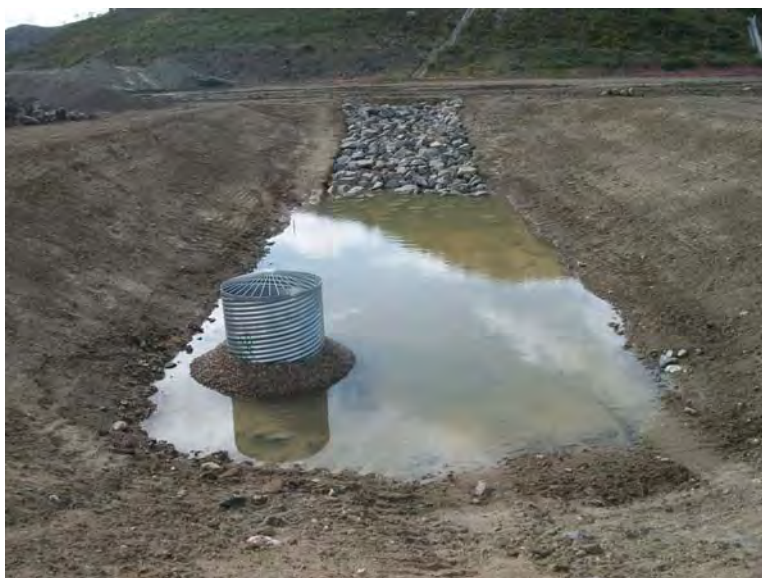
PHOTO 12.

- CYA observed several pits with ponded rainwater in the southern portion of the Site. The pit was reportedly a storm water retention basin. Based on the recent rains, the pond was observed to contain storm water. In addition, a pond was observed in the northern central portion of the Site. The pond was reportedly an artesian spring that produced groundwater that was used for dust control during the reclamation activities at the Site. The presence of the pits and the pond are not considered to be environmental concerns to the Site.

View of one of several storm water detention basins observed in the southern portion of the Site.

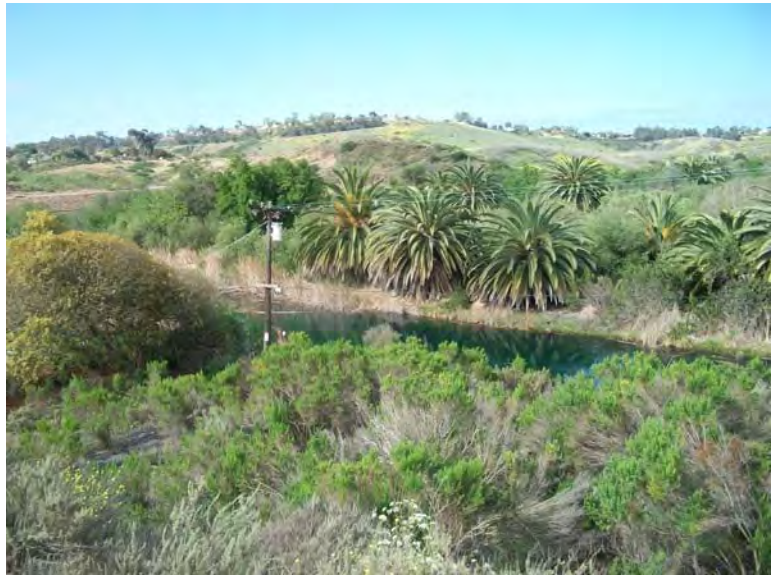
PHOTO 13.

View of the on-Site pond in the northern central portion of the Site which is reportedly fed by an artesian spring looking to the southwest.

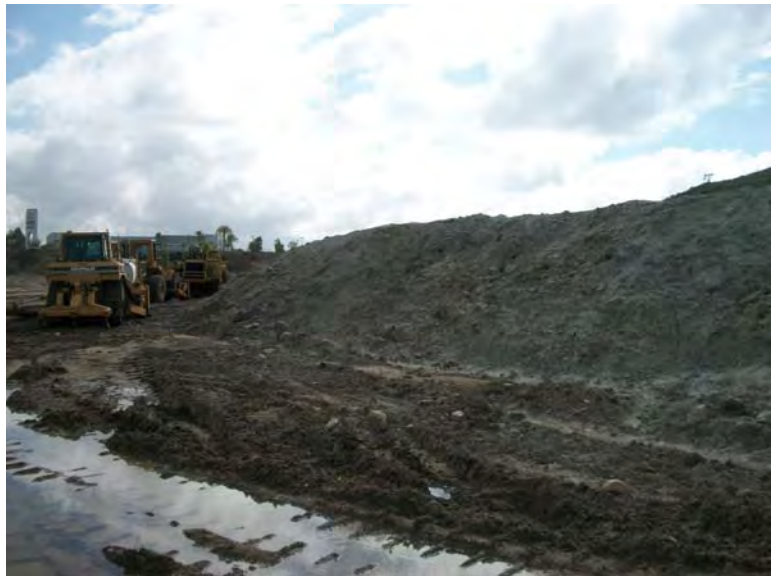
PHOTO 14.

View of one of several remaining soil stockpiles located in the southeastern portion of the Site looking to the east.

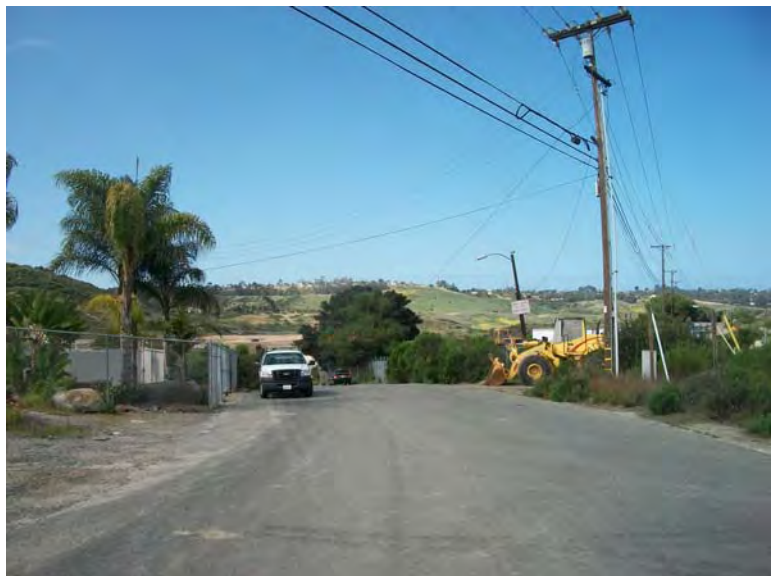
PHOTO 15.

- CYA observed five pole-mounted electrical transformers at the Site during the Site reconnaissance. One pole-mounted transformer was observed near the onsite artesian spring pond and a second electrical pole farther to the north contained three pole-mounted electrical transformers associated with onsite electrical power. In addition, one pole-mounted electrical transformer was observed on the north side of the Site to the south of Haymar Drive. The transformers are owned by SDG&E and were not labeled with respect to potential PCB content. The transformers appeared to be in good condition with no evidence of damage, leaks, or staining on or around the units. Based on the utility ownership of the transformers and observed condition of the units, CYA does not consider the transformers to be a concern to the Site.

View of one of five pole-mounted electrical transformers observed at the Site looking from the northeast corner of the Site to the southwest.

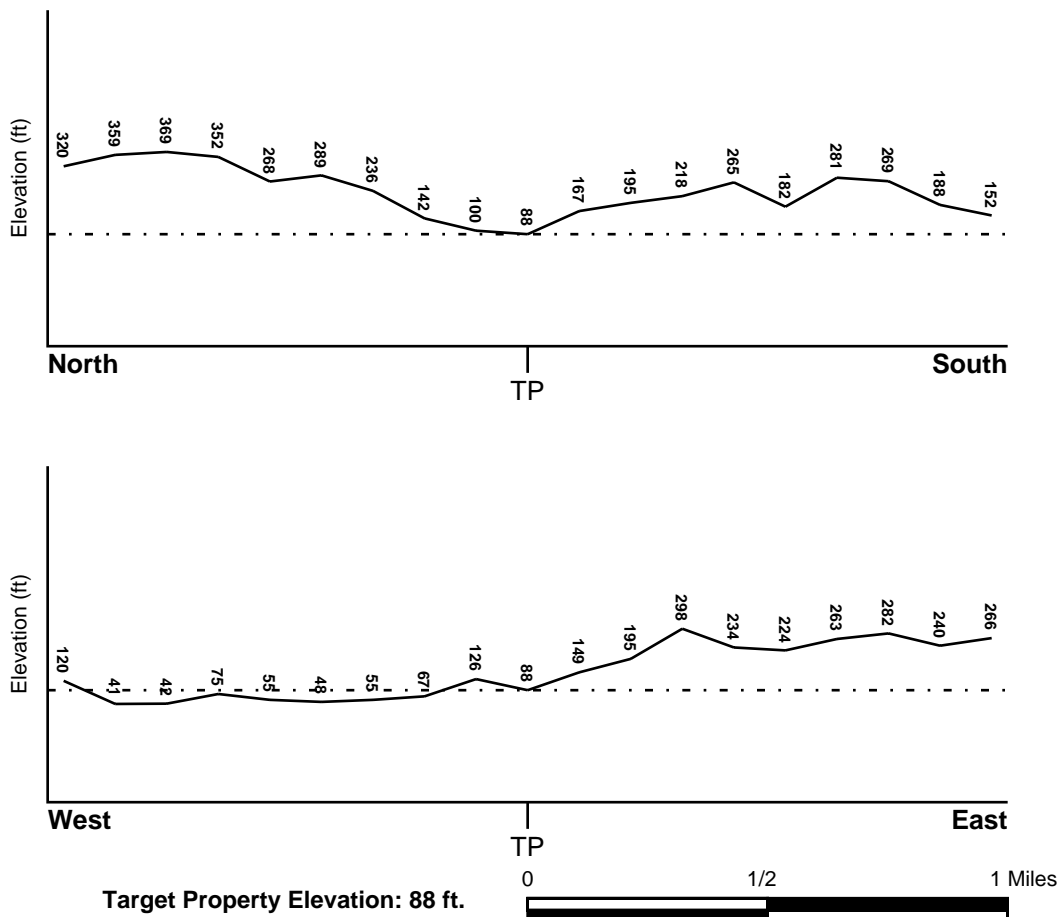
SURROUNDING TOPOGRAPHY: ELEVATION PROFILES

General Topographic Gradient: General West

Source: Topography has been determined from the USGS 7.5' Digital Elevation Model and should be evaluated on a relative (not an absolute) basis. Relative elevation information between sites of close proximity should be field verified.
